# **Building Inspection Report**

**Type of Report:** Pre-Purchase Building Inspection

Address of Property: Sample Report

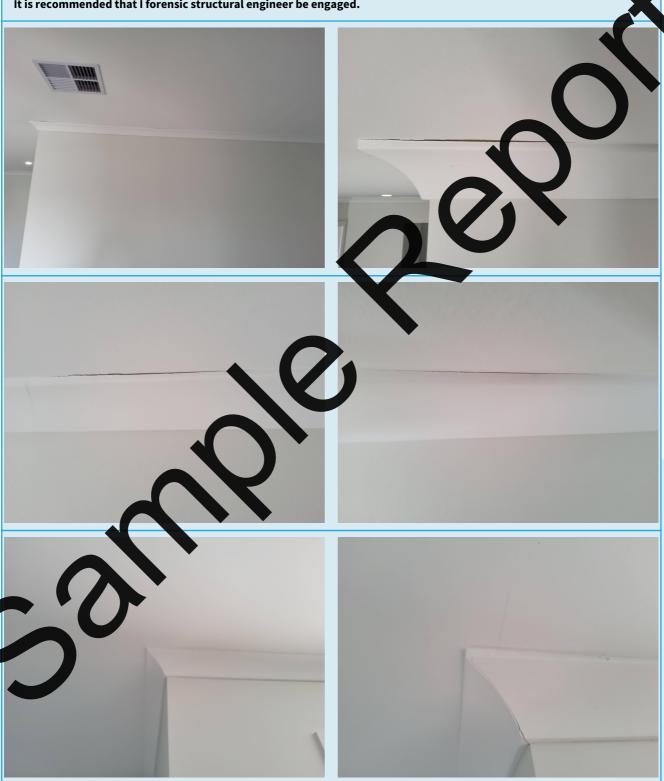
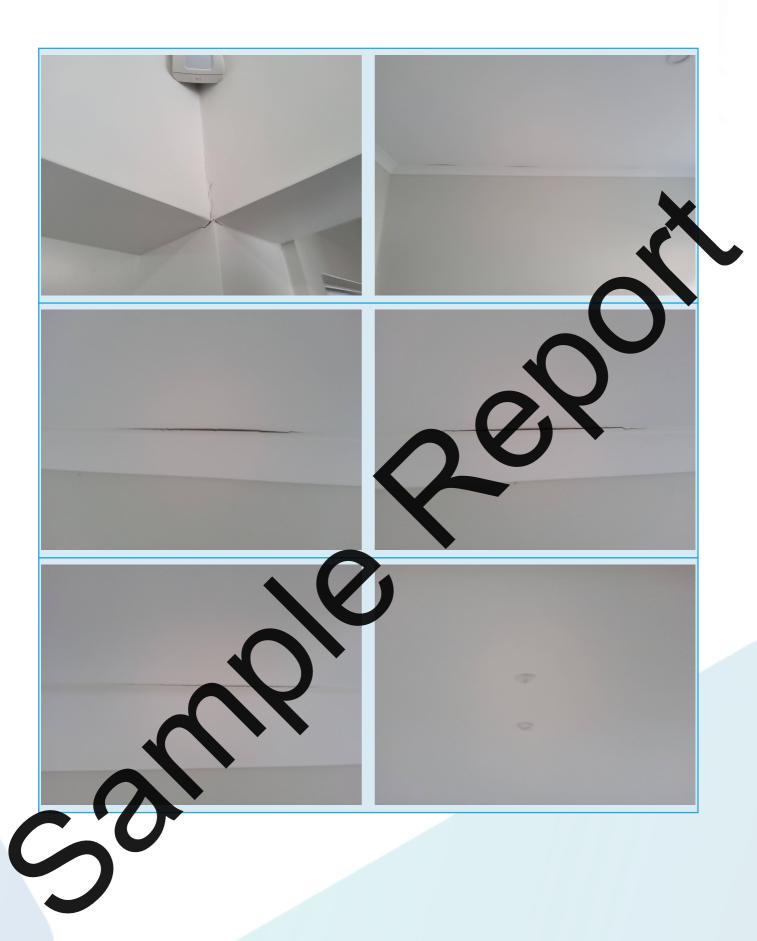
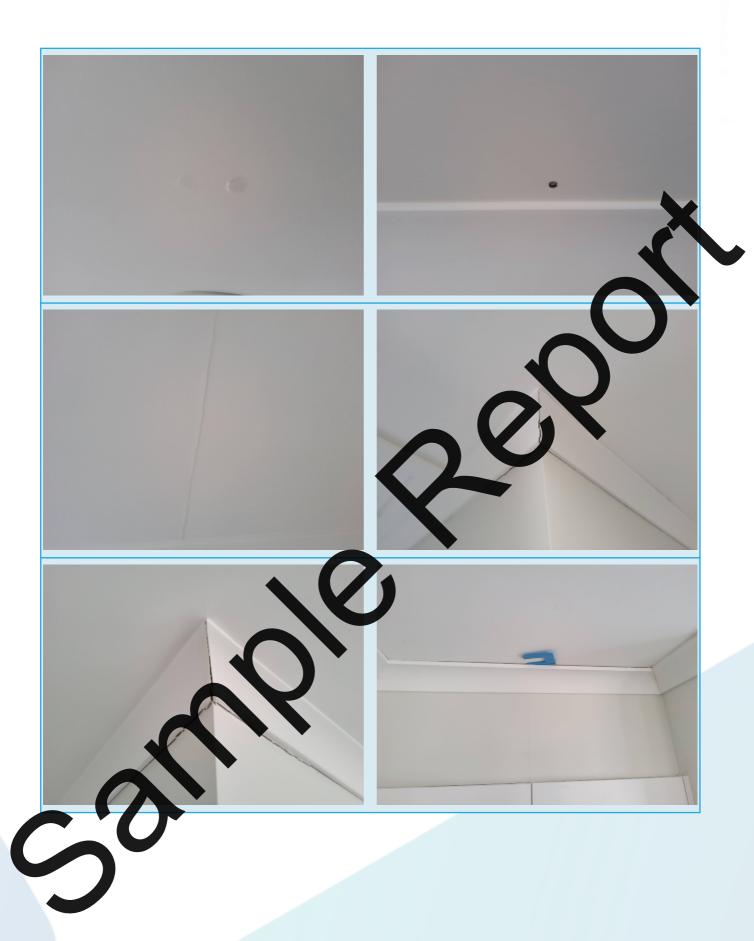
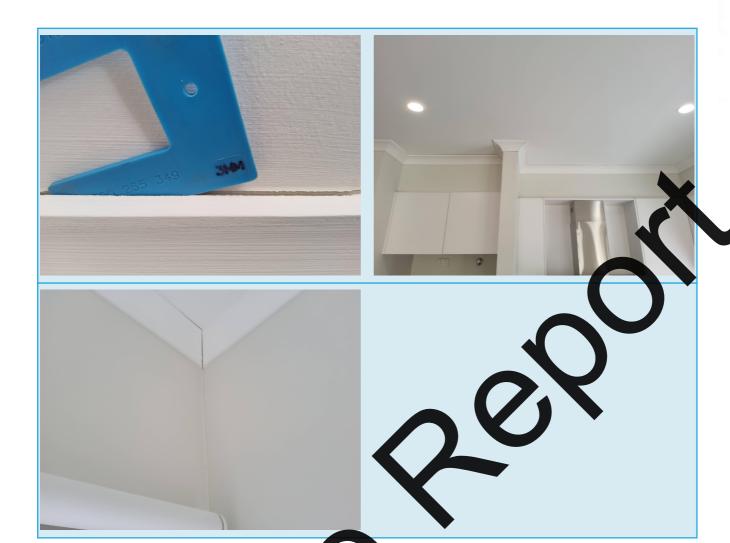
Hallways and general living spaces Ceilings **Major Defect**

Check throughout, it is noted that there is an excessive amount of cracking occurring throughout the home, particularly to the junctions between the ceilings and the cornice, there are also a number of cracks to the ceilings and to the walls.

Note: Some of the cracking exceeds 3 mm.

Cracks are primarily concentrated at the junctions between the ceiling and the comice. However, cracks have also been noted in other areas of the home, such as walls and ceilings.

The cracking is extensive and ranges from hairline cracks to crathat exceed synm, more pronounced ones, suggesting an ongoing issue.

Cracks appear to follow specific patterns, often radiating from corners and intersections. Some cracks have horizontal or vertical orientations.

It is recommended that I forensic structural engineer be engaged.

To determine the exact causes of the excessive cracking and door misalignment while adhering to Australian standards and building codes, it is strongly recommended to engage a forensic structural engineer with expertise in building assessments. The engineer should conduct a comprehensive inspection that includes the following:

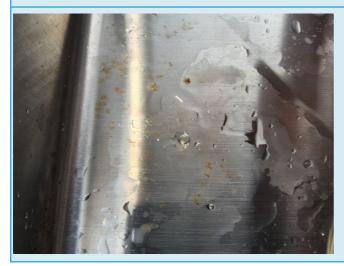
It is noted that there appears to be some surface rust occurring to the kitchen sink.

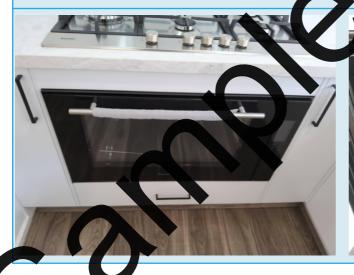
It is noted that the oven racks appear to be missing.

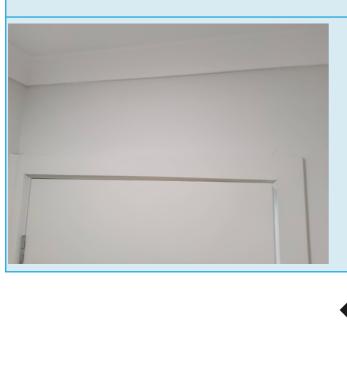
It is noted that the pantry door appears to be binding on the top of the door jamb.

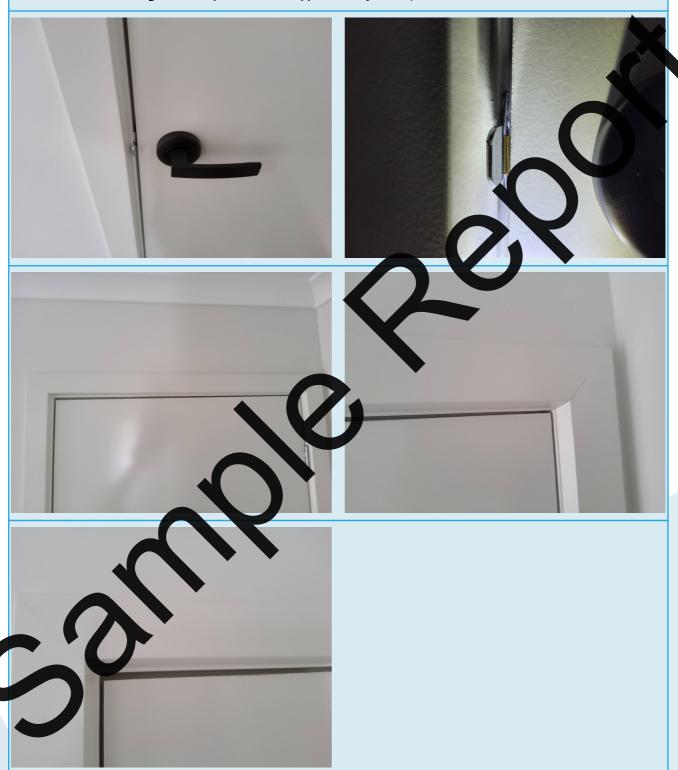
It is noted that the latch appears not to engage with the striker plate, the door also appears to be misaligned, the difference from left to right at the top of the door is approximately 10 mm, this is an indication of excessive movement.

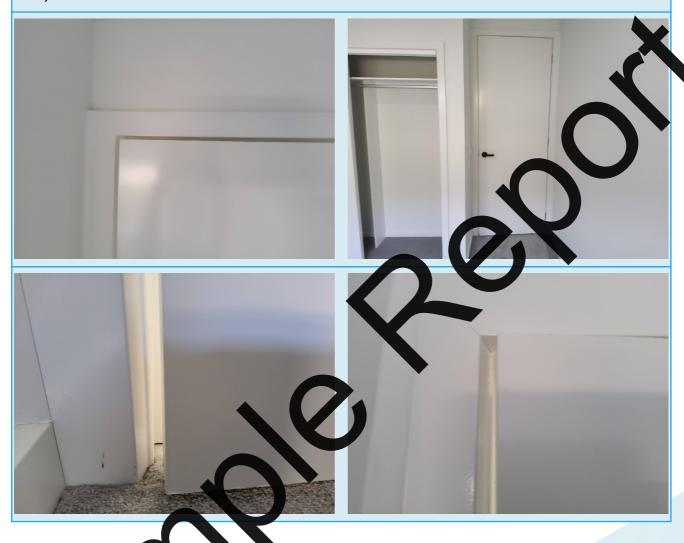
It is noted that the door appears to be misaligned, the difference from top to bottom on the latch side is approximately 10 mm, this is an indication of excessive movement.

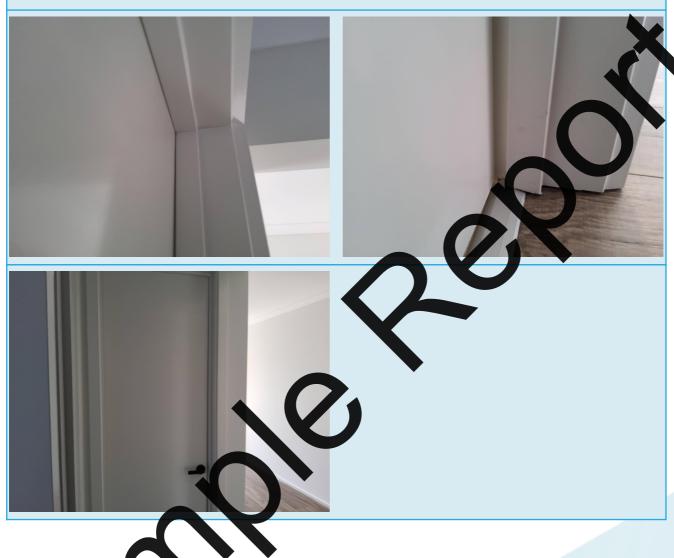
WC 2 door, it is noted that the latch side of the door appears to be misaligned with the door stop, the difference from top to bottom is approximately 10 mm, this is an indication of excessive movement.

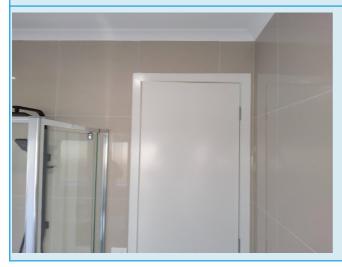
It is noted that the top of the door appears to be binding on the door jamb.

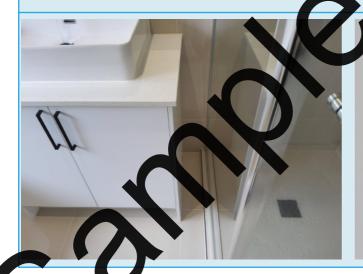
It is noted that there appears to be a gap to the silicon, located to the bottom right hand corner of the vanity unit.
