Building Inspection Report

Type of Report: Pre-Purchase Building Inspection

Type:	Domestic	Apartment
Bedrooms:	1	
Bathrooms:	1	
Ensuites:	-	
Car Park:	-	
Height:	Multistorey	
Building:	Concrete	
Piers:	-	
Floor:	Concrete	
Roof:	-	
Age:	2000s

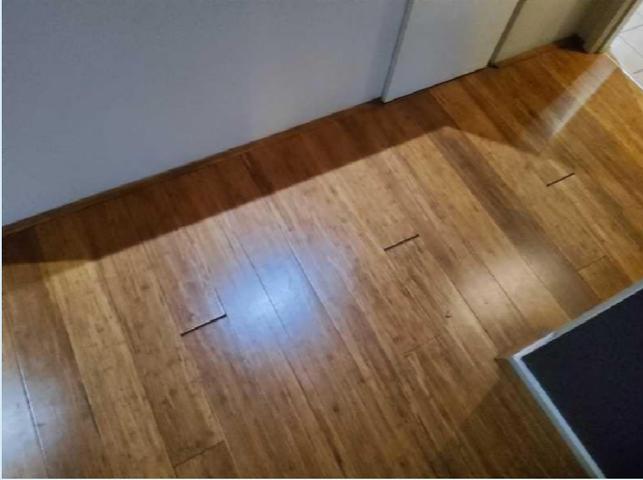
Hallways and general living spaces	
General Advice/Minor Defect	Floor
Comments	
Slight gaps between floor laminate boards, were shifted back into position.

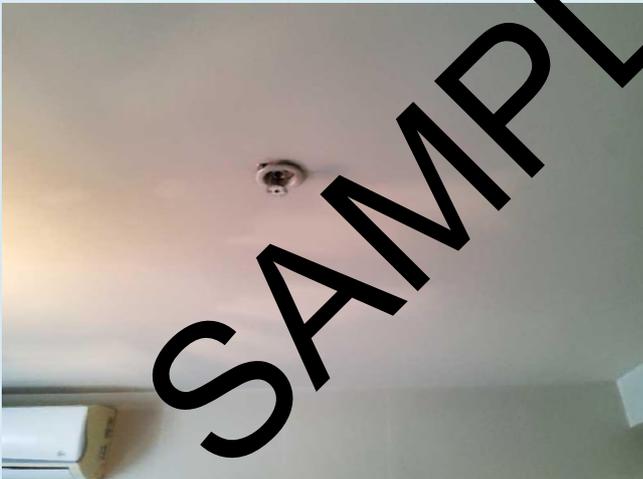
Hallways and general living spaces	
General Advice/Minor Defect	Ceilings
Comments	
Slightly detached cover around a fire sprinkler outlet, can be pushed back into position against the ceiling plasterboard.

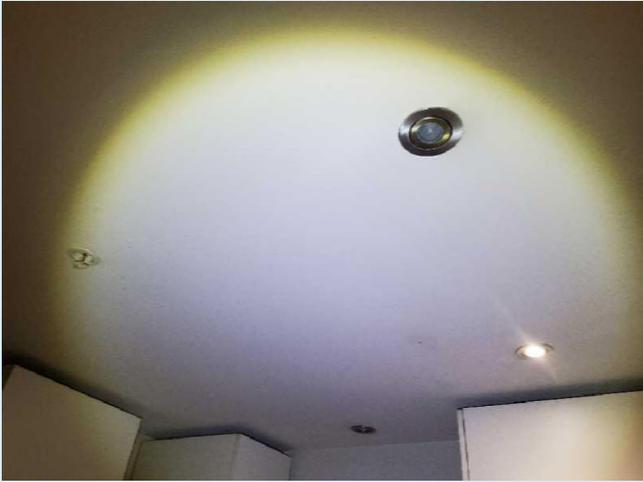
Kitchen	
General Advice/Minor Defect	Ceilings
Comments	
Two lights not working. Change light globes and if still not working, contact an electrician to assess and rectify.

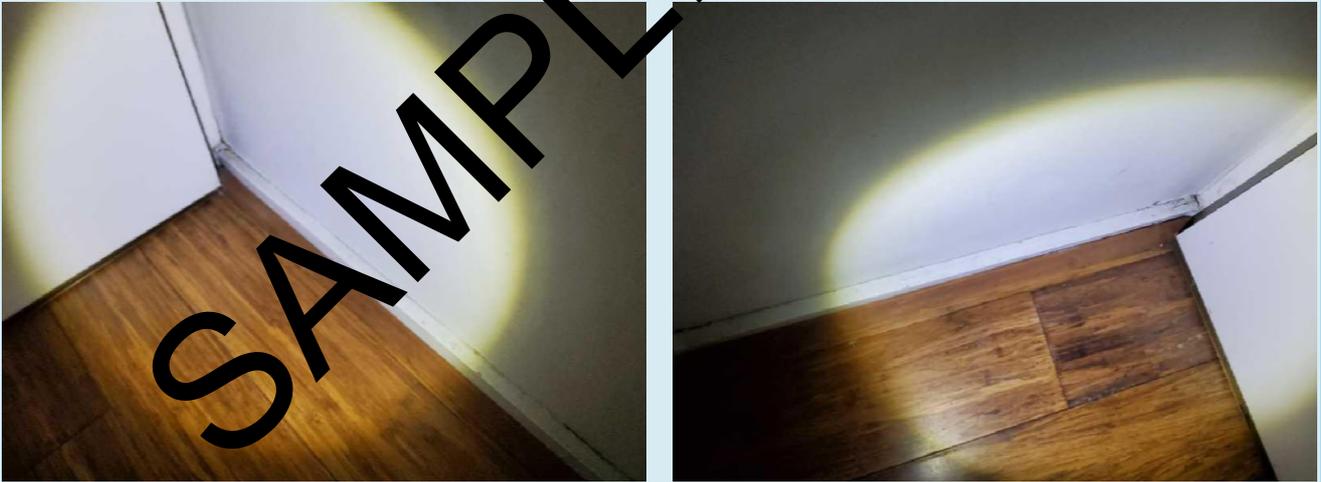
Kitchen	
General Advice/Minor Defect	Walls
Comments	
Minor gaps and cracks noted around skirting timbers. No moisture detected. Patch and paint to improve appearance.

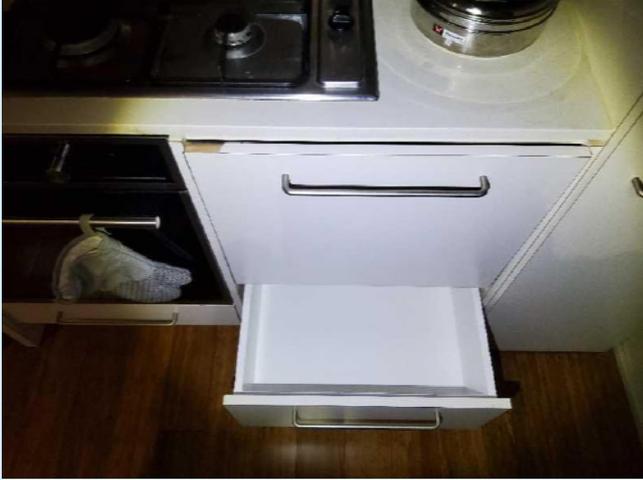
Kitchen	
General Advice/Minor Defect	Cabinets / Drawers
Comments	
Minor deterioration noted to cabinet laminate. Adjust hinges for the cabinet doors to close smoothly.

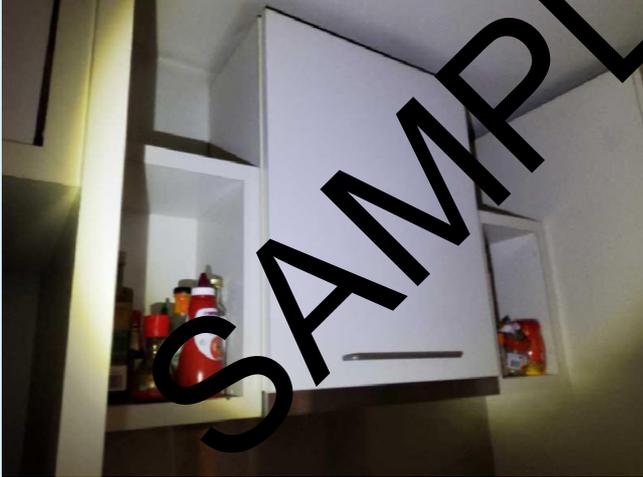
Kitchen	
General Advice/Minor Defect	Cabinets / Drawers
Comments	
Adjust hinges for the cabinet door over the range hood to close smoothly.

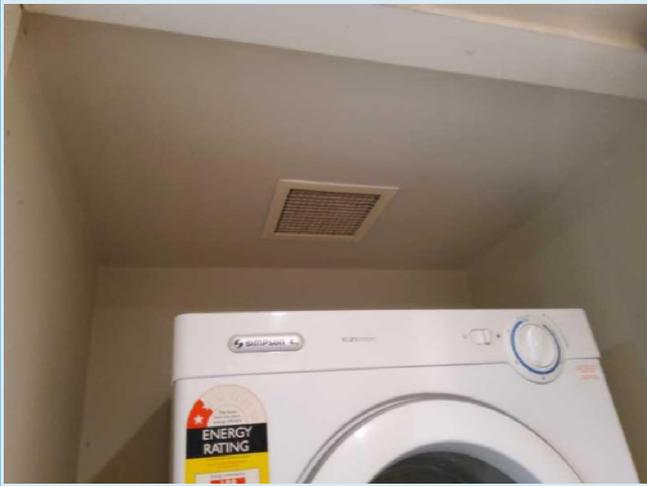
Laundry	
Major Defect	Exhaust Fans
Comments	
Exhaust fan switches on but air flow was restricted. Recommend an appliance repair contractor to service the exhaust fan or replace to improve air flow and minimise the risk of mould and other damp issues.

The apartment presents in average condition overall for its age and type of construction. No structural defects were found. Some maintenance repairs are recommended as detailed in the comments above. Of highest priority is to improve exhaust ventilation in the bathroom and laundry.

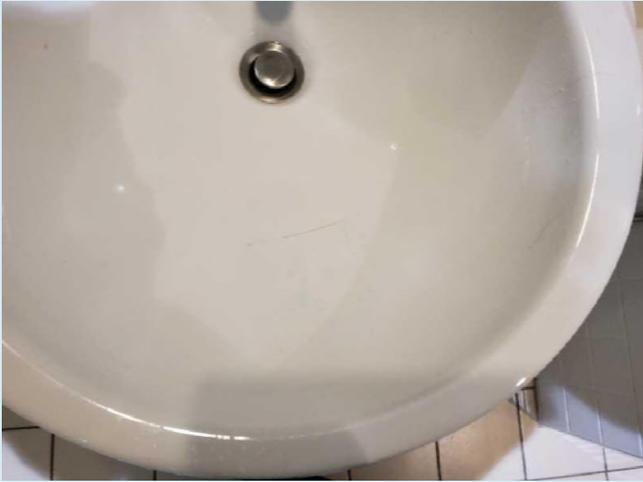
Bathroom 1	
General Advice/Minor Defect	Basins
Comments	
Very fine hairline cracks noted to the basin. Replace basin as required.

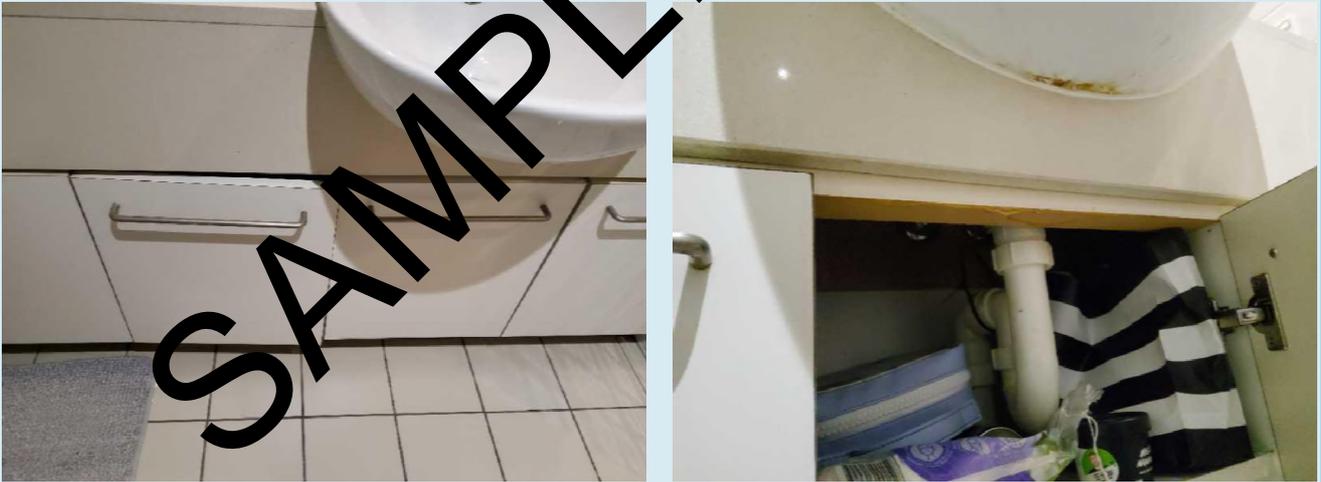
Bathroom 1	
General Advice/Minor Defect	Cabinets
Comments	
Adjust hinges for the cabinet doors to close smoothly. Minor water deterioration noted to cabinet below the sink.

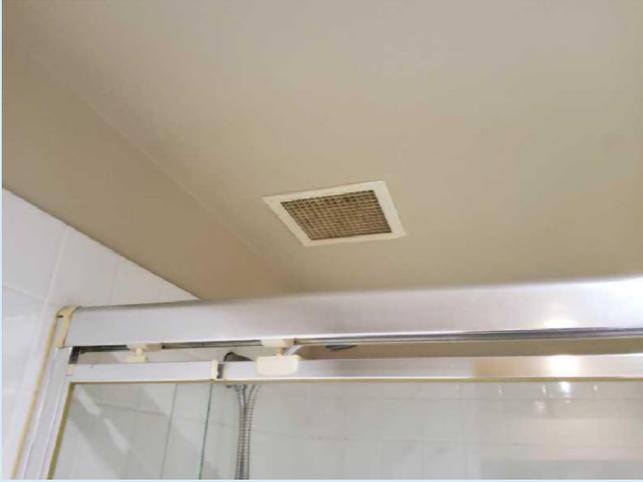
Bathroom 1	
Major Defect	Ventilation
Comments	
<p>Exhaust fan switches on but air flow was restricted. Recommend an appliance repair contractor to service the exhaust fan or replace to improve air flow and minimise the risk of mould and other damp issues.</p>

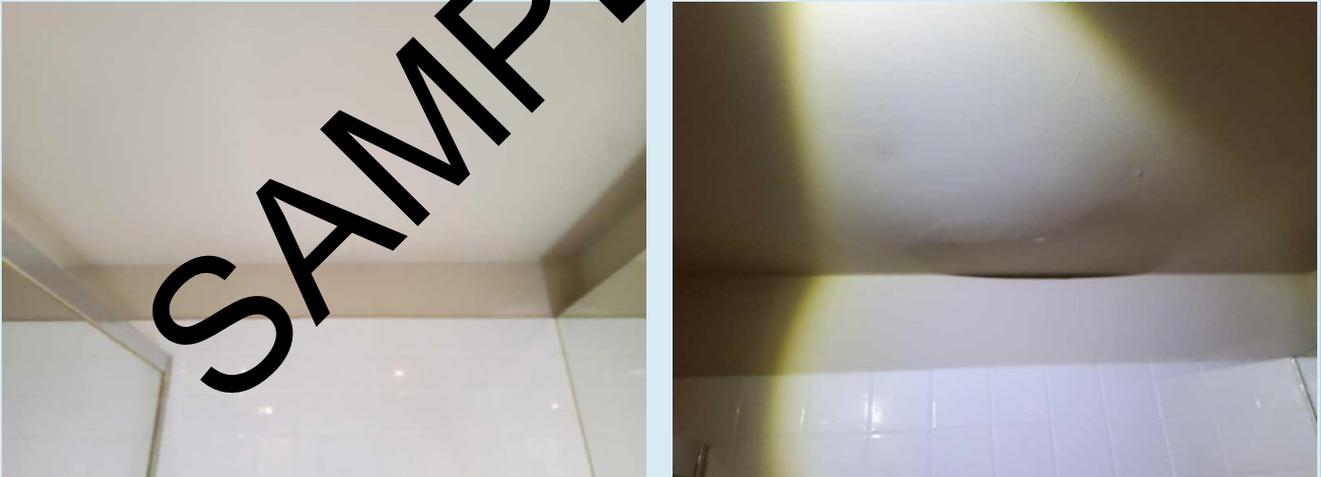
Bathroom 1	
General Advice/Minor Defect	Ceilings
Comments	
<p>The ceiling plasterboard surface was uneven, suspected to be due to past leak from above, but dry at the time of inspection when tested by moisture meter. Monitor over time for any further deterioration and if found, contact a plumber or waterproofing contractor. For advice on other apartments and common areas repairs, please contact your conveyancer or solicitor.</p>
