# **Building Inspection Report**

**Type of Report:** Pre-Purchase Building Inspection

Address of Property: Sample Report

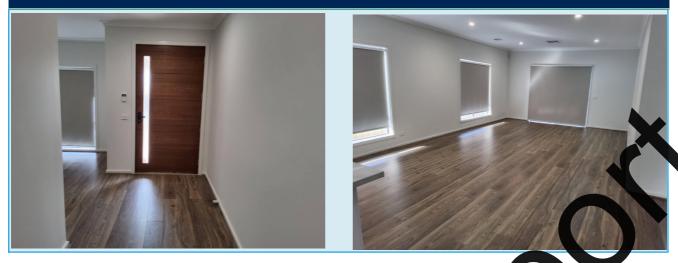
# 5. Hallways and general living spaces

Condition Visually Fine	General Advice/Minor Defect	Major Defect	Unable to inspect Due	Not Applicable
Floor		₫			
Walls	₫				
Ceilings			V		
Doors		₫			
Windows	₫				
Fireplace					₫
Stairs					₫
Balustrade					₫

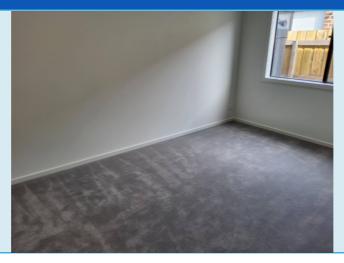
## 8.2. Bedroom 2

Condition Visually Fine	General Advice/Minor Defect	Major Defect	Unable to Ir spect Des	Not Applicable
Floor	₫				
Walls	₫				
Ceilings	₫				
Doors	₫				
Windows	₫				
Robes	₫				
Smoke Detectors					₫

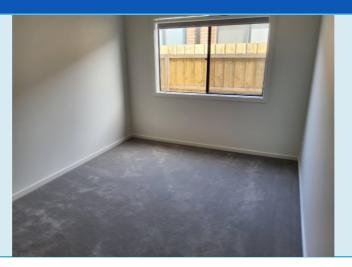
## 8.3. Bedroom 3

Condition Visually Fine	General Advice/Minor Defect	Major Defect	Unable to Ir spect Due to Access	Not Applicable
Floor	₫				
Walls	₫				
Ceilings	₫				
Doors					
Windows	₫				
Robes	₫				
Smoke Detectors					₫

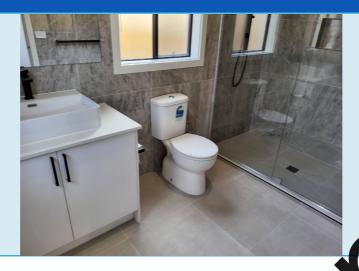
# 10.1. Ensuite 1

Condition Visually Fine	General Advice/Minor Defect	Major Defect	Unable to Inspect Due	Not Applicable
Floor	₫				
Walls	₫				
Ceilings	₫				
Doors	₫				
Windows	₫				
Shower Recess	Ø				
Shower Screen	đ				
Shower Rose	₫ <u> </u>				
Bath	П				₫
Taps					
Cabinets	Q				
Sealants	<u>V</u>				
Basins	ď				
Toilet	₫				
Ventilation	đ
